AIRCRAFT ACCIDENT REPORT

CRASH DURING LANDING
FEDERAL EXPRESS, INC.
MCDONNELL DOUGLAS MD-11, N611FE
NEWARK INTERNATIONAL AIRPORT
NEWARK, NEW JERSEY
JULY 31, 1997

NTSB/AAR-00/02

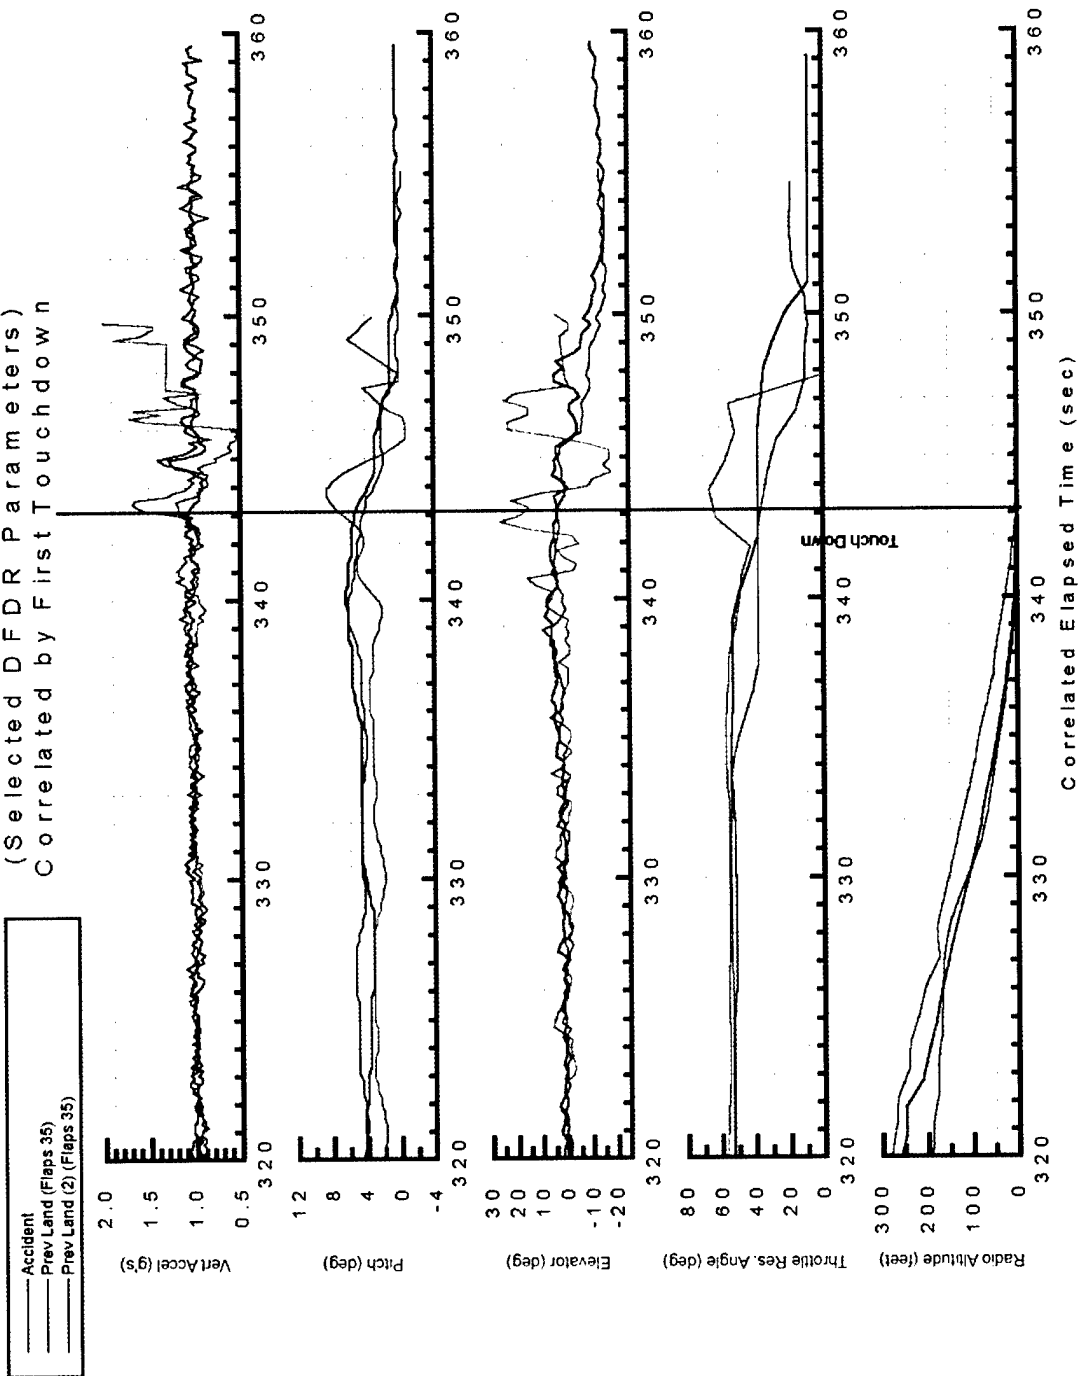
Figure 6. Comparison of selected DFDR parameters for accident landing and previous two landings (correlated by first touchdown).

As the airplane touched down at 0132:18.6, pitch attitude and vertical acceleration were increasing (along with engine speeds). It touched down 1,126 feet beyond the runway displaced threshold with a 7° nose-up pitch attitude. Vertical speed at the time of the first touchdown was about 7.6 feet per second (fps).²³ Vertical acceleration peaked at 1.67 g. About 1/2 second after the first touchdown, the FDR recorded an 18° AND elevator deflection (maximum possible MD-11 AND elevator deflection is 27°) and a TRA decrease.²⁴ At 0132:19, rudder deflection decreased to near zero, and the magnetic heading stabilized at 217.4° (the published magnetic heading for the runway was 219°). Pitch attitude peaked at 8.44° and began decreasing. Thrust continued to increase with N_1 values of about 65 percent. Airspeed began to increase and the airplane became airborne.²⁵

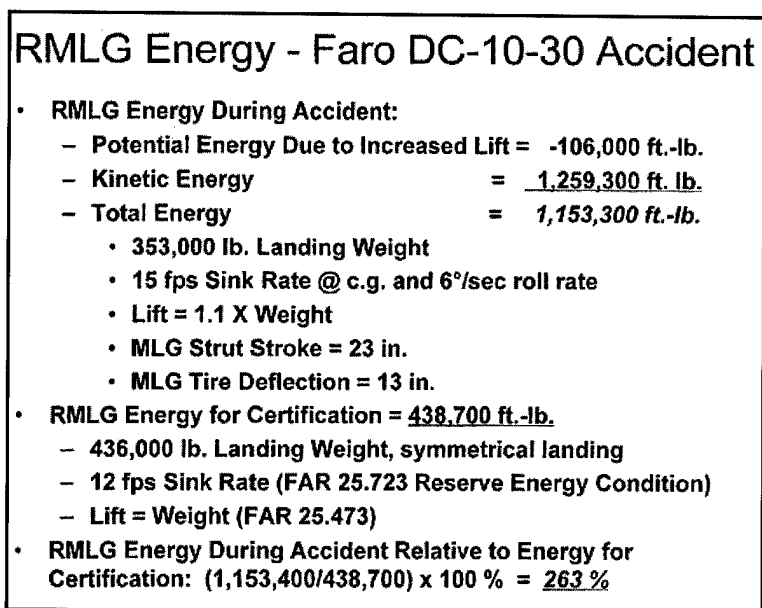
[A]t a landing weight of 353,000 [pounds], lift at start of touchdown of approximately 1.1 times the aircraft weight, and descent rate at the aircraft [c.g.] of approximately 15 fps and roll rate of 6 [degrees per second], the kinetic energy, 1,259,300 ft-lbs, was decreased by potential energy (from increased lift) by approximately 106,000 ft-lbs, for a total energy of approximately 1,153,000 ft-lbs on the [right] MLG. Comparing the Faro accident energy with the DC-10-30's [right] MLG energy required for certification shows that the energy developed during the Faro accident landing was over 2 and a half times the reserve energy (ultimate) certification requirements for a single [MLG].

Figure 10. Boeing calculations of right MLG energy in the Faro accident.

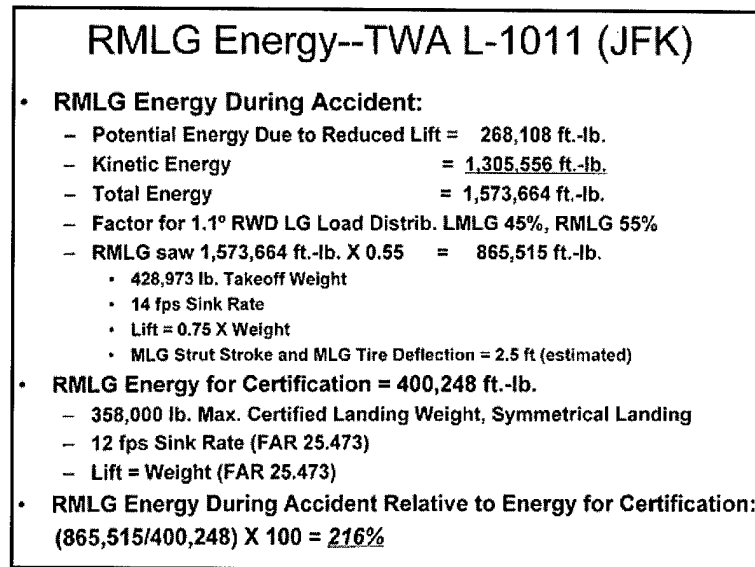
Figure 11. Boeing calculations of right MLG energy in the TWA L-1011 accident.
